THE HYOGO-KEN NANBU (KOBE) EARTHQUAKE OF 17 JANUARY 1995

A FIELD REPORT BY EEFIT

EEFIT March 1997

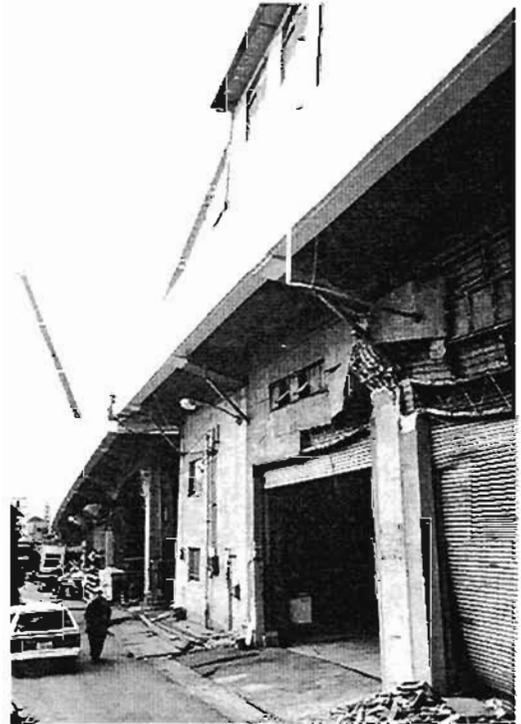
Plate 4.180: Incipient external transverse hinge

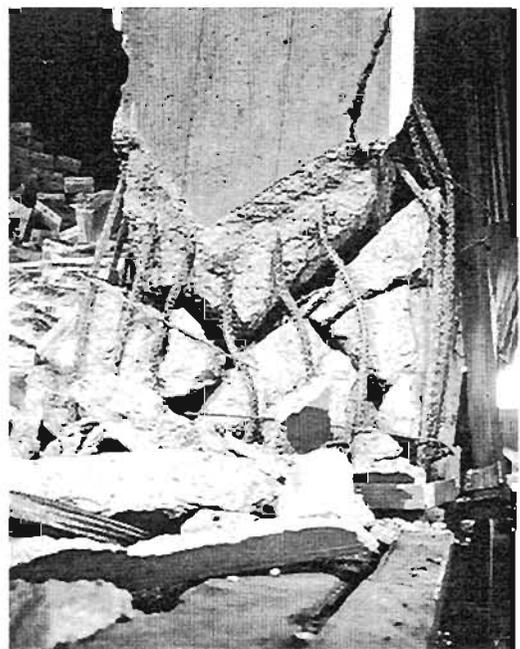
Plate 4.184: Anvil in shear hinge and incipient spreading of column beneath

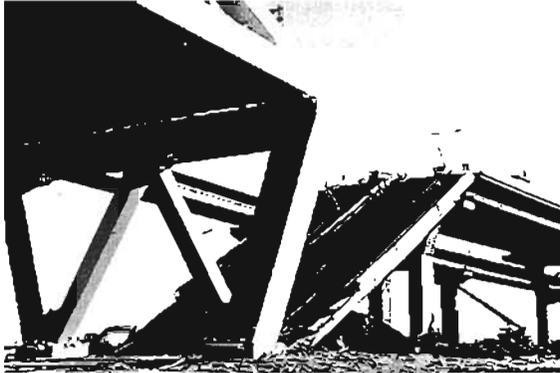
The Shinkansen bullet train line suffered collapses at several locations along the elevated section to the north of Nishinomiya. One of these is pictured in Plate 6.6 taken shortly after the earthquake, and the same dropped span is shown in Plate 6.7 taken by the authors. It is unclear whether collapse was initiated by loss of bearing or by collapse of the reinforced concrete columns. This particular span was simply supported on relatively narrow bearing shelves, with joints at each end. The spans either side appear to have been strengthened by a very deep beam between the columns. This will have had the effect of reducing the length of the columns and thereby stiffening them longitudinally.

Plate 6.6 Shinkansen Bullet Train Line near Nishinomiya: Collapse of simply supported span between two continuous sections of bridge. Note deep beam between columns in spans either side of collapse (photo taken immediately after earthquake);

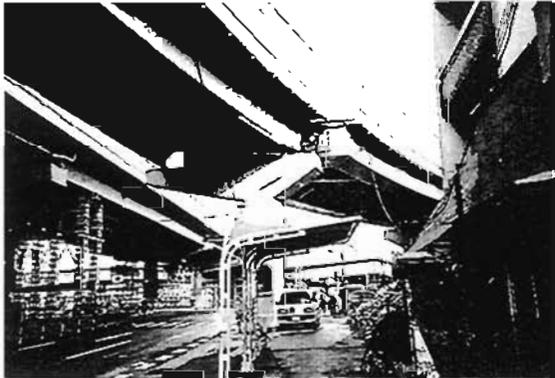
Plates 6.9 and 6.10 show the dangerous shift of a curved box girder which forms part of the same interchange illustrated in Plate 6.8.

Plate 6.9 Hanshin Expressway to the west of Kobe centre: Large sideways shift towards south of curved deck, same interchange as Plate 6.8

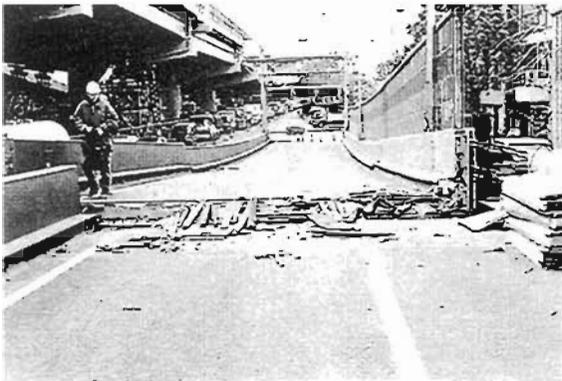
Plate 6.11 Ramp onto Hanshin Expressway near centre of Kobe: Approximate one metre shift of first ramp span towards the north

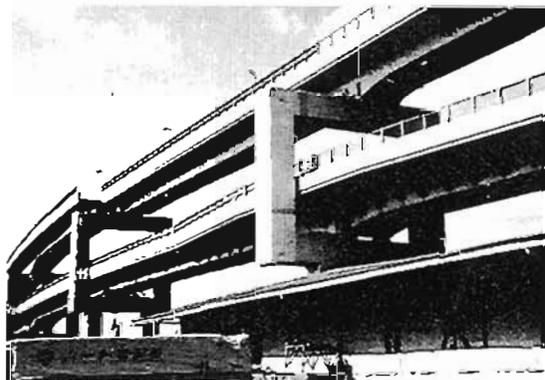
There were numerous examples where decks had shifted without collapse. Some of the most spectacular examples were on the Route 2 multi-level viaducts which run close to the shoreline near downtown Kobe (Plates 6.16 and 6.17). It was clear that some of the devices to prevent spans falling off their supports, introduced by code requirements (Section 6.7), were not designed for an event such as this. On the Hanshin Expressway plates which had been bolted across joints between steel girders had sheared the bolts when they

Plate 6.16 Multi-level Section of Route 2 near downtown Kobe: large transverse displacement of upper deck at movement joint

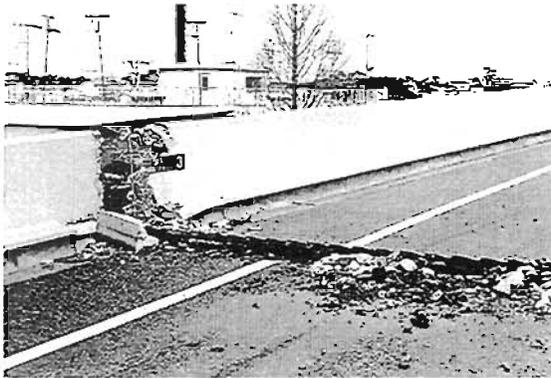
Plate 6.23 Ramp onto Hanshin Expressway near centre of Kobe: Hammering at joint has damaged deck joint and parapets

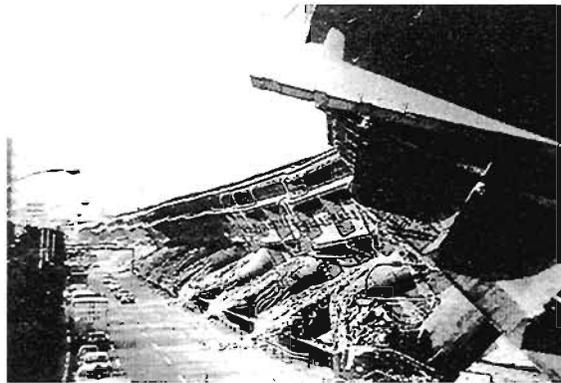
The best known collapse of elevated viaduct was the 635m long section of Kobe Route 3 on the Hanshin Expressway. The 4-lane Route 3 was supported above the 8-lane Route 43 by columns in the central reserve, and the deck collapsed onto the northern carriageway of Route 43. Design for this section was carried out in the early 1960's and construction commenced in 1969^{6.1}. The 35m deck spans comprise table-top sections monolithic with the single column piers, and central deck sections spanning 22m between half-joints (Figure 6.2). Restrainers were fitted across the half-joints. This structural form has no redundancy, and the 635m of viaduct collapsed through flexure/shear failure of the brittle 3100mm diameter columns. Plate 6.24 taken shortly after the earthquake shows the mode of failure. Plate 6.25 shows a close-up of the first column of the all-concrete spans near the foreground of Plate 6.24. Reference 6.1 indicates that the longitudinal reinforcement in the columns consisted of three concentric rings of 60-D35 bars up to a height of 2.5m above the top of pilecap, at which point the inner ring was curtailed. The outer two rings of main bars had binding reinforcement of 16mm diameter bars at 200mm centres, while the inner ring had 16mm bars at 400mm. For a column of these proportions this amount of containment reinforcement is inadequate, and it could not sustain the shear loads nor confine the longitudinal rebar and concrete under the large inertia loads from the heavy deck. The flexure/shear failure initiated at the location of the curtailment of the inner ring of main bars.

Plate 6.24 Hanshin Expressway, Kobe Route 3, Fukae-Honcho Section toppled 635m of all-concrete viaduct due to flexure/shear of single column piers.

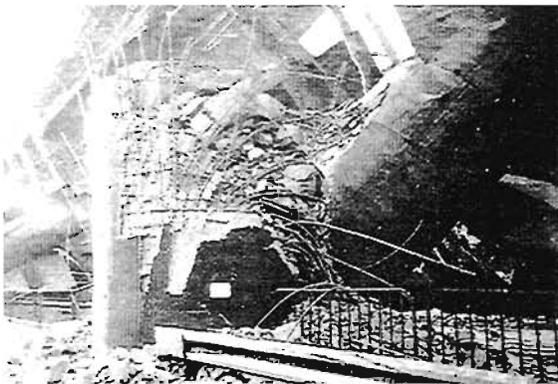
Plate 6.25 Hanshin Expressway, Kobe Route 3, Fukae-Honcho Section close-up of pier in foreground of Plate 6.22 showing small lateral bars and curtailed longitudinal bars.

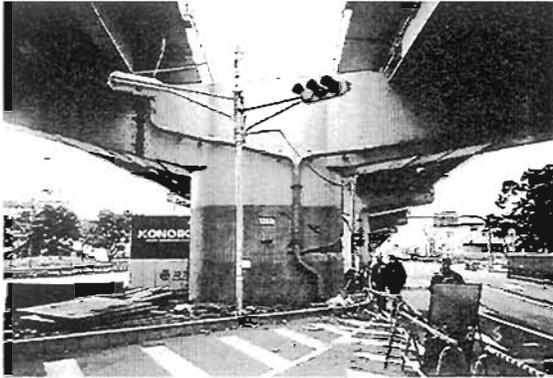
Plate 6.31 Hanshin Expressway, Kobe: Damage to large pier at level of construction joint and/or curtailment of reinforcement.

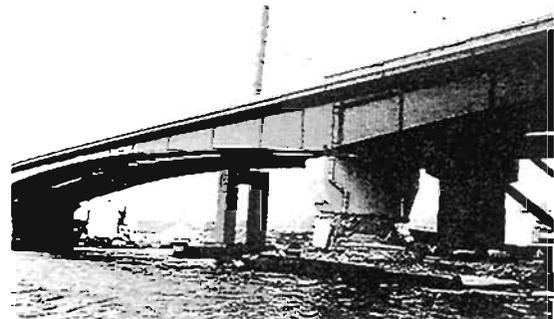
The Maya Ohashi Bridge carries the Harbour Highway which connects various offshore berths on the sea side of Maya Harbour. Both of the wide main piers supporting the twin steel box girder superstructure were badly damaged. The east pier had failed completely at a change in section near mid-height, which probably also coincided with a construction joint (Plates 6.38 and 6.39). Sliding had occurred at this plane, leading to an estimated 350mm northward drift of the upper part. The longitudinal reinforcement was continuous, but there were no through-wall ties, simply transverse bars which were lost with the cover. The lateral movement on the east bank had occurred due to extensive liquefaction of the bank (Plate 6.40). The approach span pier two away from the east main pier, pictured in the centre of Plate 6.40, suffered severe damage to accommodate the distortion at the main bridge pier (Plate 6.41). At one end of this wide pier gas welds between vertical bars had failed (Plates 6.42 and 6.43). The piers either side of this failed pier were twin column portals, and being more flexible were undamaged.

Plate 6.38 East Pier of the Maya Ohashi Bridge on the Harbour Highway failed completely at a change in section near mid-height, leading to a 350mm northward shift of the upper part

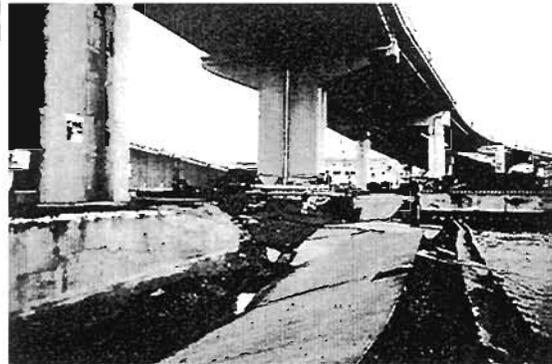
Plate 6.40 East Bank at the Maya Ohashi Bridge on the Harbour Highway liquefaction caused extensive lateral spreading

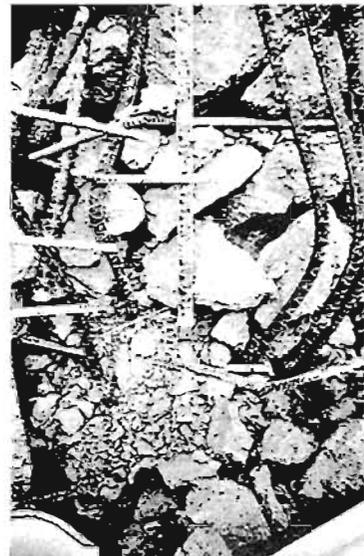
Plate 6.42 Pier on East Approach to the Maya Ohashi Bridge on the Harbour Highway damage at one corner of the pier in Plate 6.41 - note the failure of the welded bar in the centre of the Plate

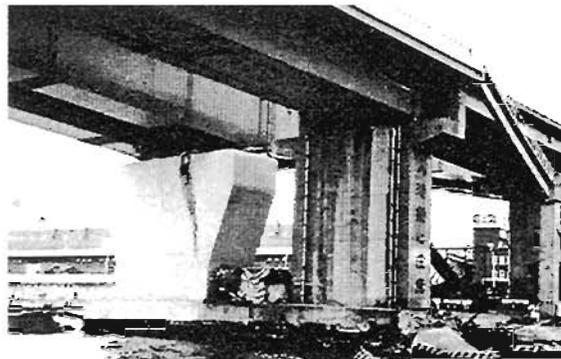
The west main pier of the Maya Ohashi Bridge showed a shear split (Plate 6.44) as a result of the large transverse load transmitted to the pier from the bearing. To accommodate transverse thermal movements the designer probably restrained the deck transversely at one bearing only, hence all the inertia load would have come on that bearing. Given the magnitude of the forces, it is impressive that the bearings remained intact, and that the steel box girder appeared undamaged.

Plate 6.44 West Main Pier of the Maya Ohashi Bridge on the Harbour Highway shear split as a result of large transverse load transmitted from the bearing

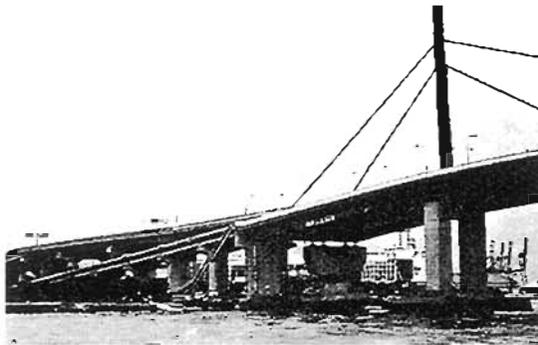
Alongside the Maya Ohashi box girder bridge there was a single tower cable-stayed bridge to carry local port traffic (Plate 6.45). This structure was undamaged apart from some disruption at the top of the steps.

Plate 6.45 Cable-stayed Bridge alongside the Maya Ohashi Bridge structure was undamaged apart from some minor damage at the top of pedestrian access stair

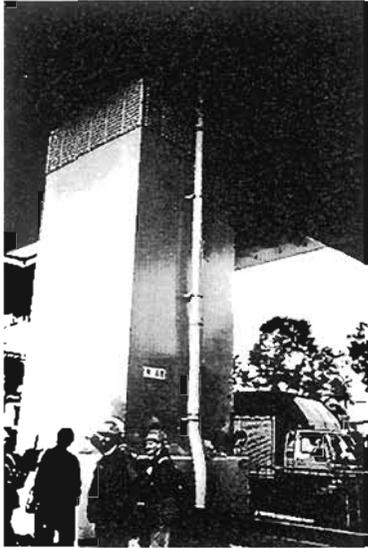
Plate 6.47 Hanshin Expressway - Damage to Rectangular Steel Pier Column stiffened walls buckled exposing orange coloured primer/undercoat

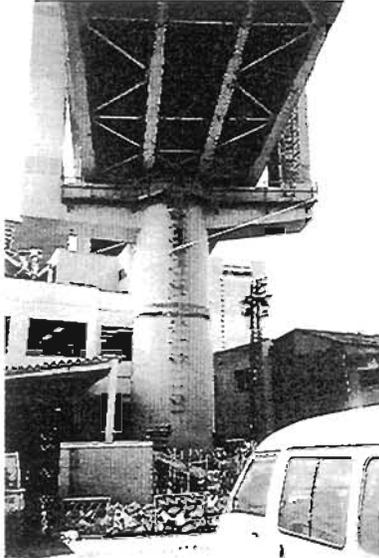
The columns of the later and much taller double-decked Route 2 were of either steel box or steel tubular form. They seemed to fare reasonably well; but were designed to a more stringent code. Some distress was noted; for example the circular column in Plate 6.51 viewed along the line of the structure, and in close-up in Plate 6.52 viewed transverse to the line of the structure, shows a very symmetric buckle at a change in column wall thickness. Similarly, the buckling damage to the stiffened box column on the Route 2 viaduct a little closer to the centre of Kobe (Plate 6.53) is likely to be at a change in section at the first panel of thinner material.

Plate 6.51 Hanshin Expressway Route 2 near the centre of Kobe- Damage to Circular Steel Pier Column viewed along the line of the structure shows a symmetric buckle at change in wall thickness

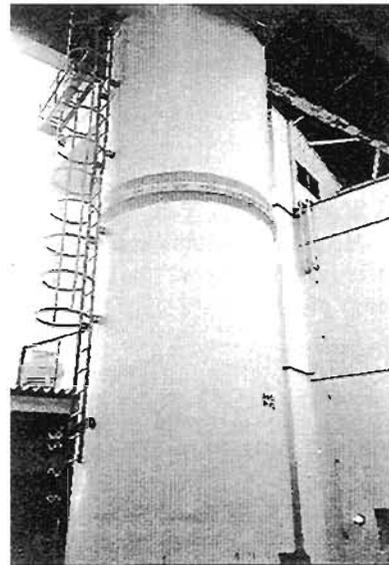
Plate 6.52 Hanshin Expressway Route 2 near the centre of Kobe- Damage to Circular Steel Pier Column viewed normal to the line of the structure shows symmetric buckle at change in wall thickness

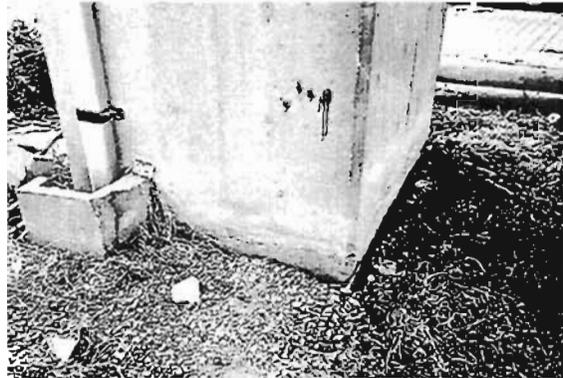
Plate 6.58 Railway near Centre of Kobe - Damage to Steel Portal Pier centrifugally cast columns lacked ductility

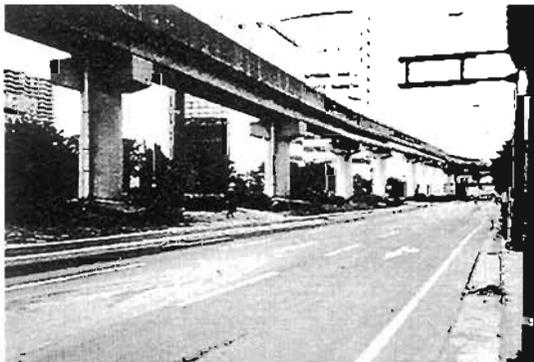
Plate 6.59 JR Shinkansen Bullet Train Viaduct near Nishinomiya signs of movement and settlement around pier column

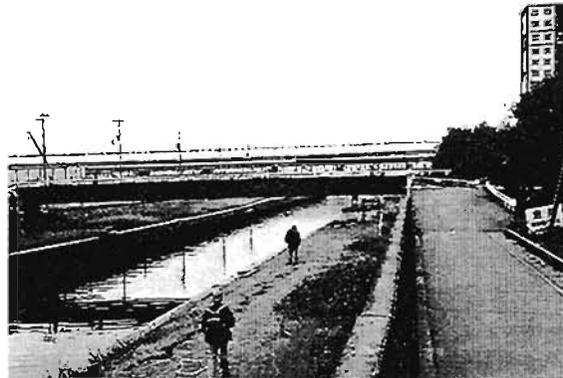
Plate 6.62 Steel Box Girder Road Bridge over Canal, Kobe Ground either side of canal moved towards canal shortening span. Abutment wall moved forward and buckled flange and web of box girder.

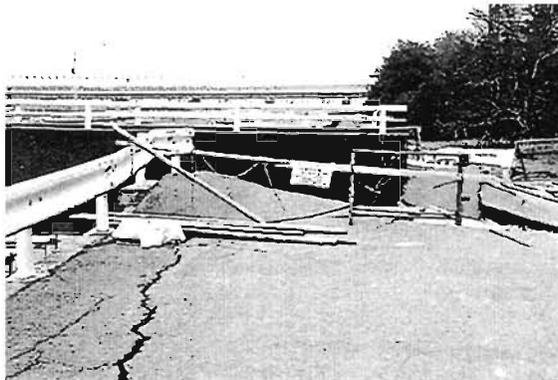
Plate 6.63 Footbridge over Canal, Kobe lateral spreading caused banks to move inwards, and girder sliced through roadway

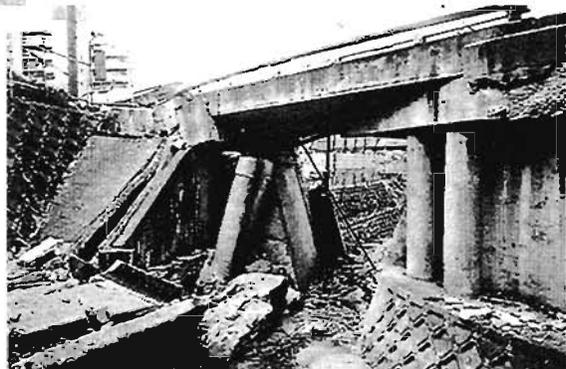
Plate 6.65 Single Span Bridge to the North of Nishinomiya Ground movements caused collapse of columns and loss of material from behind abutments

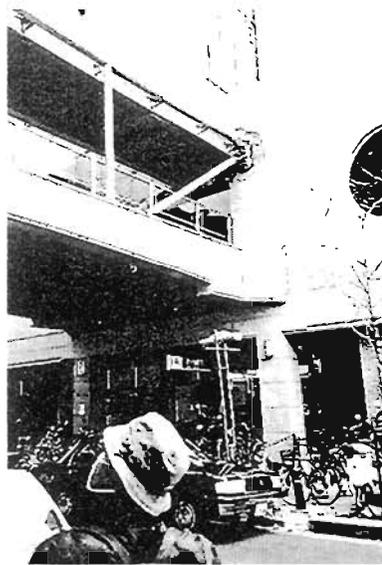
Plate 6.66 Footbridge Linking Buildings in Kobe Out of phase movements caused buckling of tubular steel members

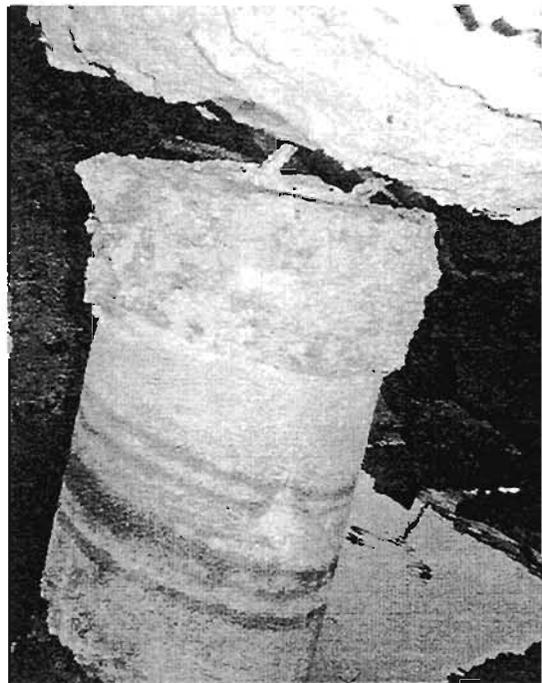
The majority of the Process Building at Uozaki remained undamaged, this being largely attributed to the piled foundations, which had been exposed by settlement in places. Cracking had occurred in some of the hollow precast concrete piles (Plate 7.11). In the harsh maritime environment, there may be long term integrity problems with the constant movement of saline groundwater. It was observed in several areas (such as the ferry terminal, Plate 38) that many of the piles were either lightly connected to the base above (Plate 7.12) or had no apparent connection at all (Plate 7.10).

Plate 7.12
Poorly connected
RC pile

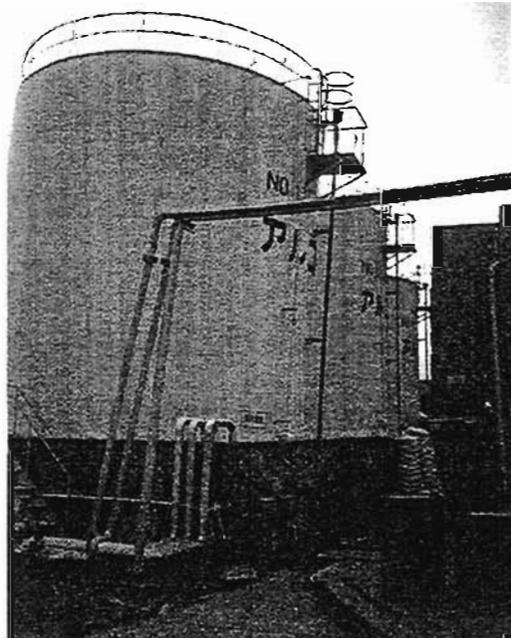
A number of steel tank farms were inspected and generally no major damage was noted, although some movement was apparent from distortion of pipes. (Plate 7.24) and one of the taller tanks showed a typical buckling failure (Plate 7.16). In most cases, the reinforced concrete base slab supporting the tanks were supported on piles. At Higashi-Nada power station, excavations were in hand to determine the extent of damage to the piles (see 8.1.4 in Chapter 8).

Plate 7.24
Lightly restrained pipes
deformed not fractured

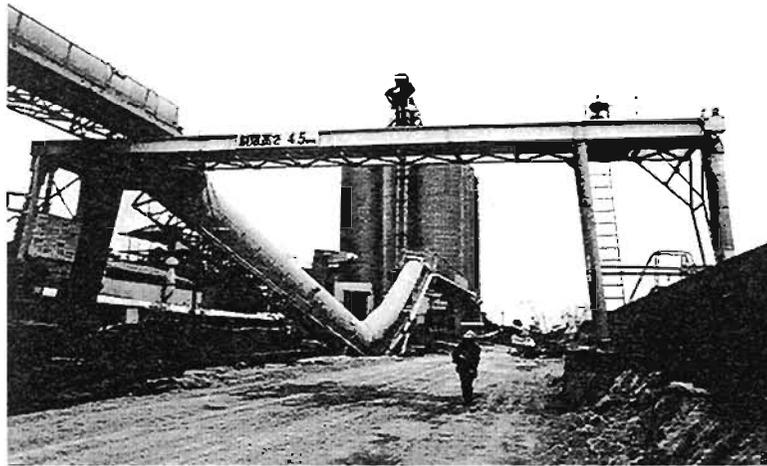
Plate 7.37 Collapsed section of conveyor

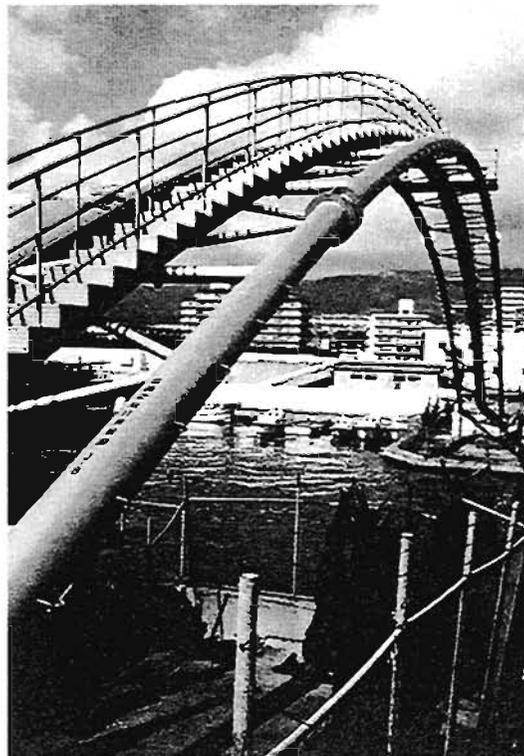
Plate 7.39
Arch pipebridge
Intact despite
support movement

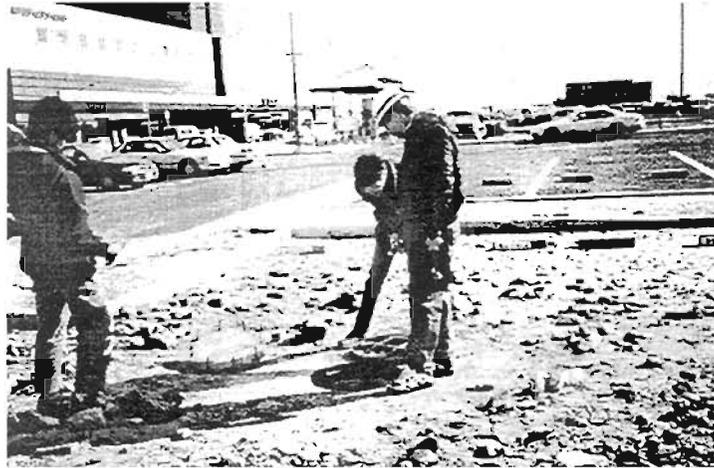
Plate 8.1: Liquefied soil deposits coming out from a manhole in Port Island

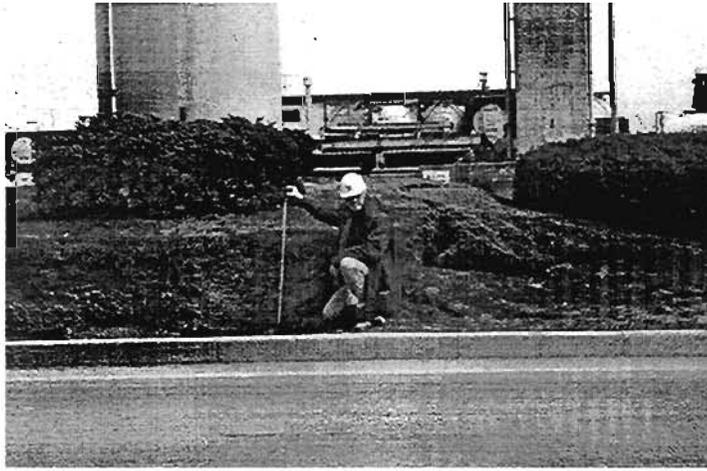
Plate 8.3: A layer of liquefied sands erupted from the ground

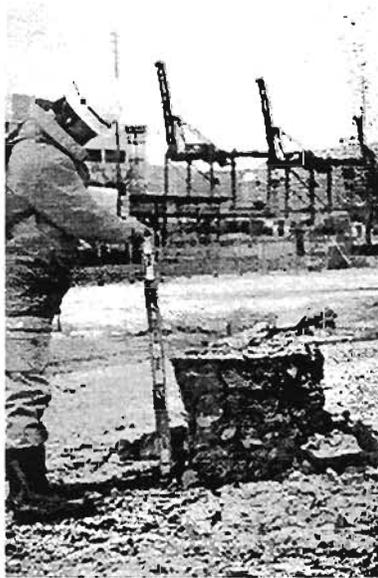
Plate 8.4: Liquefaction settlement observed at a pier of the elevated Portliner railway in Port Island

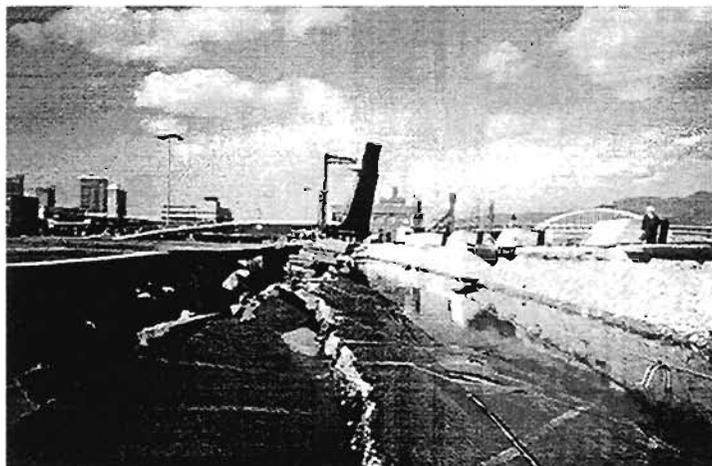
Plate 8.8: Lateral movement of concrete caisson walls in Rokko Island

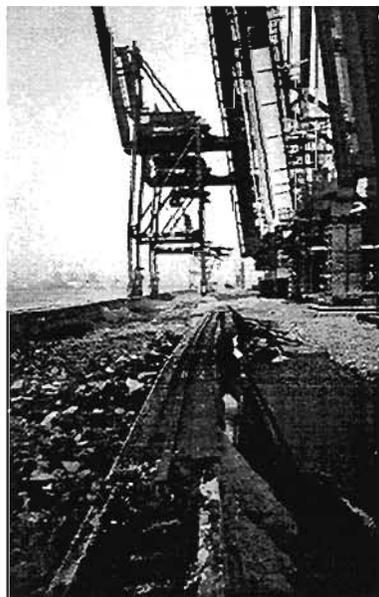
Plate 8.11: Exposed piles under the concrete block foundation of the cranes in Port Island

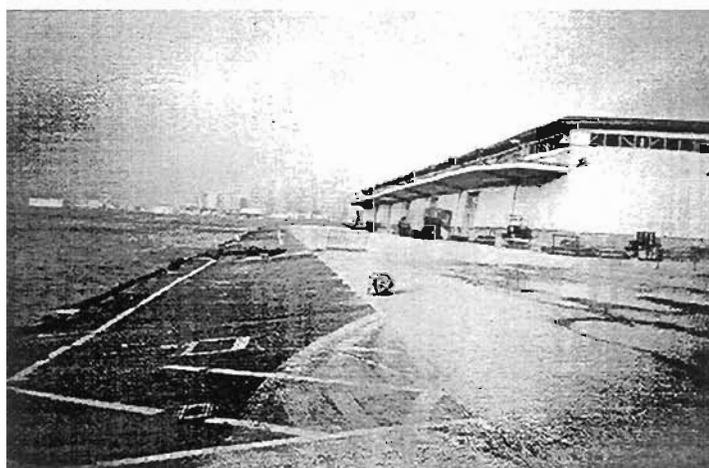
Plate 8.14: A dried water splash marker of liquefied soils found at the toll gate box on Port Island

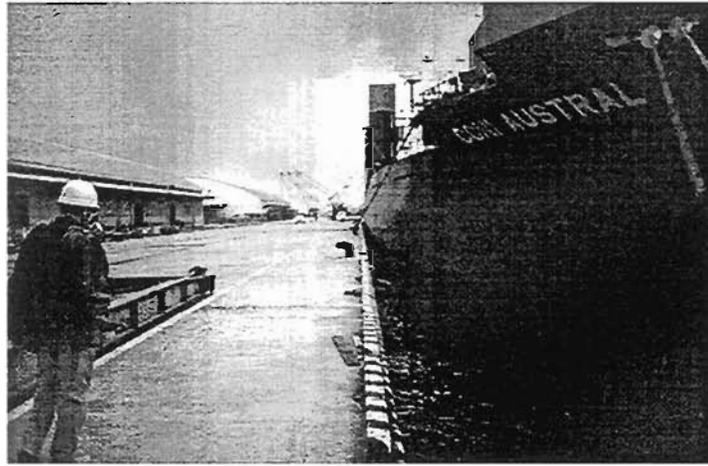
Plate 8.18 Extensive lateral movement of quay walls at the Maya Futo wharves

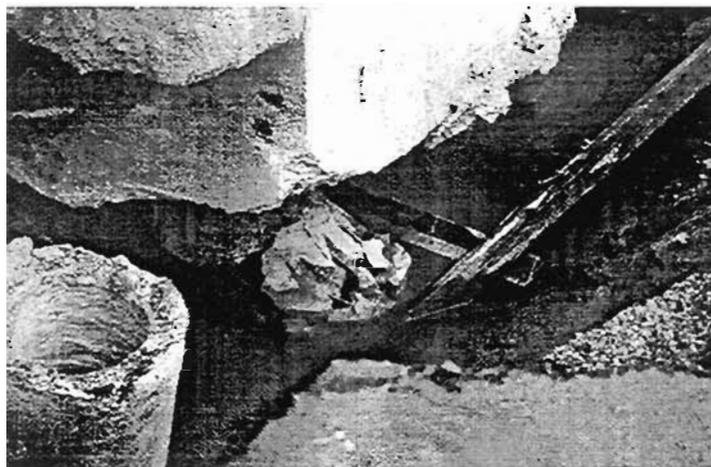
The effect of liquefaction on pile foundation was very hard to discover because they needed to be excavated for inspection (see Plate 8.20). Not much damage to piles has been reported since the earthquake, but the number of piles suffering damage is expected to increase with time (e.g. Tokimatsu et al. (1996)).

Plate 8.20: Damaged pile foundation due to soil liquefaction (photo by Prof. K. Tokimatsu)

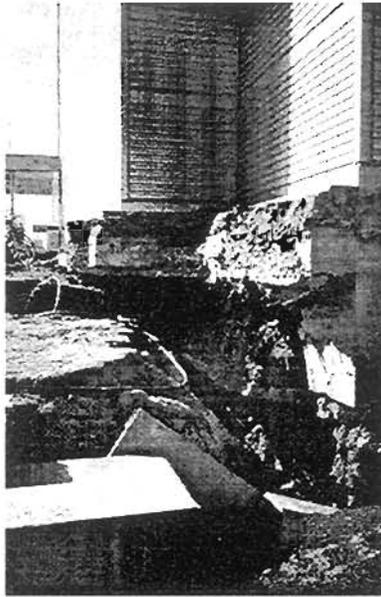
Plate 8.27: Lateral movement of the surface ground pushing the pier of the Nishinomiya Bridge

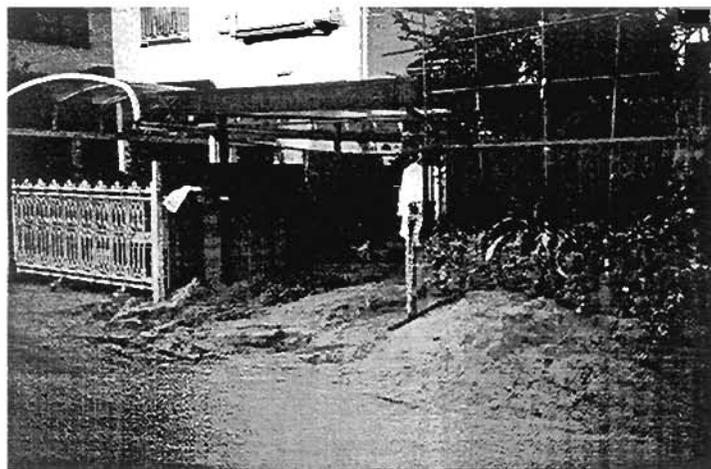
Plate 8.29: Tilting of a three story office building affected by lateral spreads

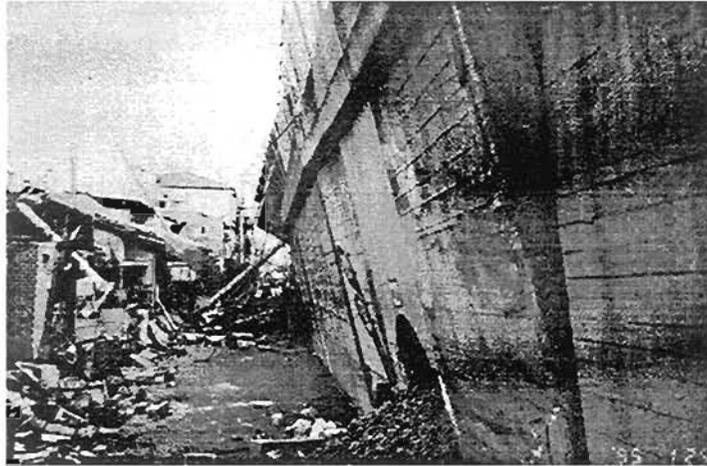
Plate 8.33: Collapse of the Daikai Station

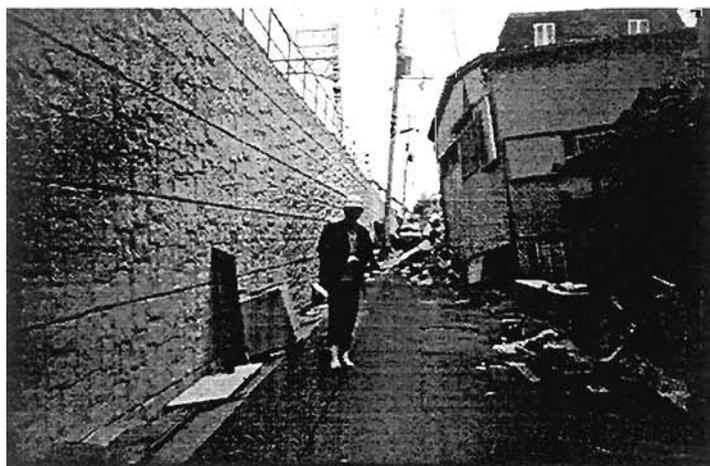
Plate 8.35: Collapse of a masonry stone retaining wall (photo by Prof. J. Koseki)

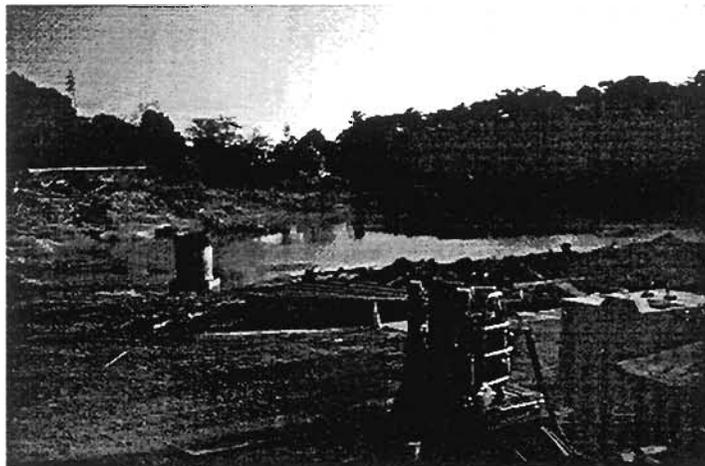
Plate 8.37: Lateral displacements observed at the geotextile reinforced wall in Tanata

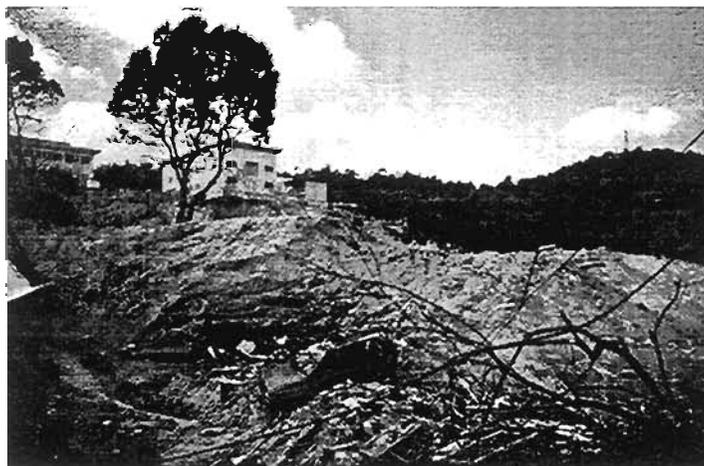
Due to the strong motion of the earthquake, the north and east sections of the bank protection and the two embankments collapsed (Figure 8.27 and Plate 8.38). The failure pattern appears to be deep sliding downstream. The subsurface soil is reported to be fine sands or sandy silts, strongly suggesting that

Plate 8.38: Liquefaction failure of the Niteko reservoir
